IG Repair Company Debuts Repair Process; Raises Industry Concern

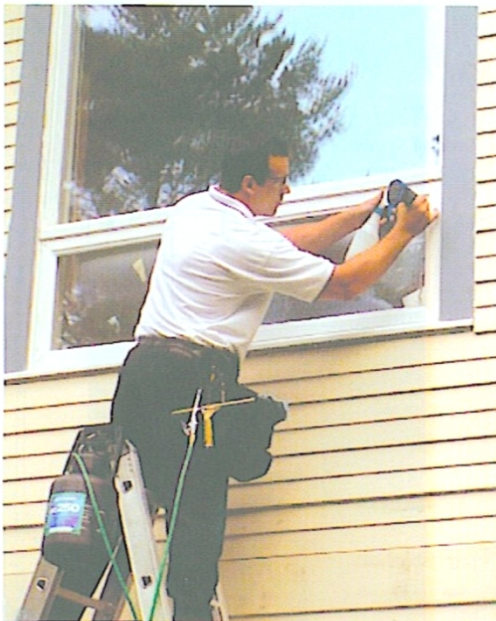
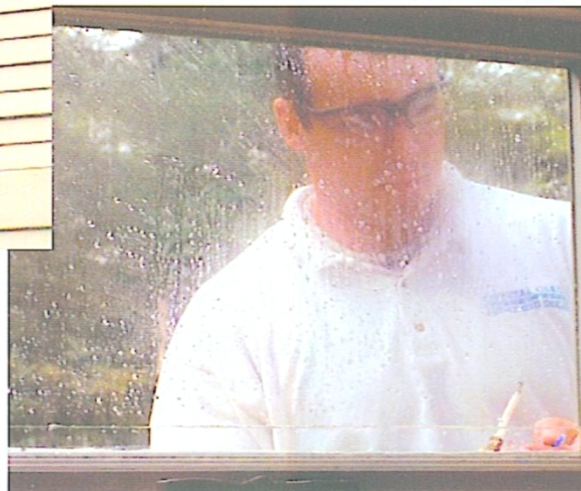
(above and right) The CCWW process begins with an assessment of the IG. The process is designed to remove moisture and fogging from failed IG units.

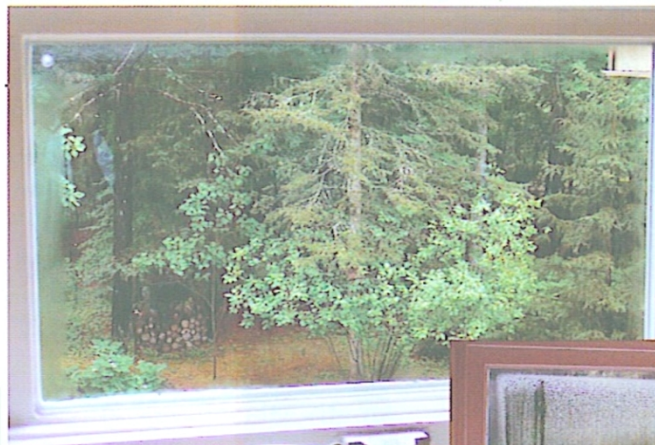
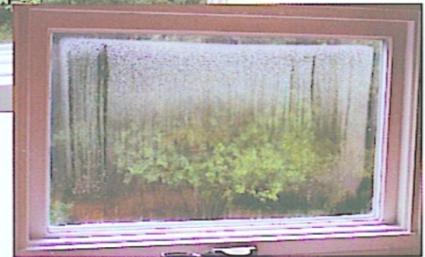
The CCWW process is applied to failed IGU units (right) to remove fogging that may have occurred (above).
